NATIONAL DAM INSPECTION PROGRAM. HILLTOWN DAM (NDS ID NUMBER PA--ETC(U)

HILLTOWN DAM, BUCKS COUNTY  
PENNSYLVANIA

PHASE I INSPECTION REPORT,  
NATIONAL DAM INSPECTION PROGRAM

AUGUST 1980

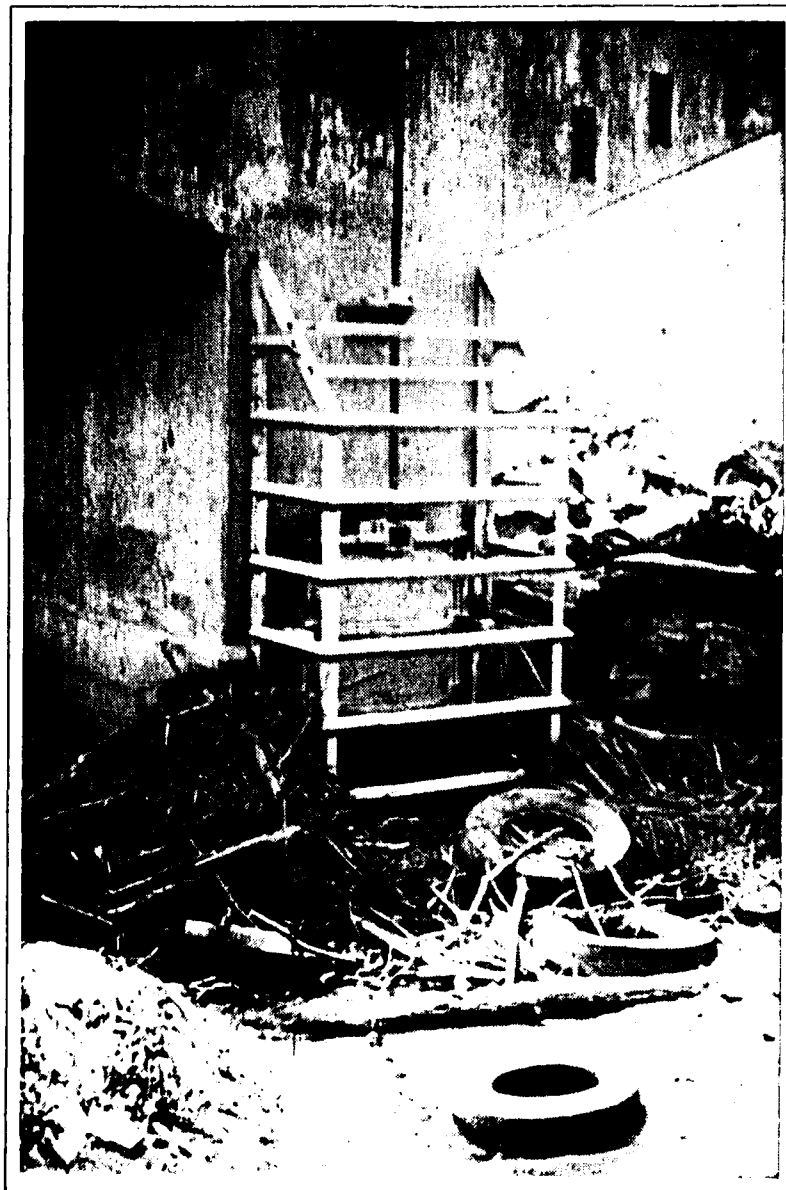
PHOTOGRAPH NO. 11

d. Reservoir. The dam will not impound water under normal conditions, and trees were left standing in the reservoir area. A thin layer of sediment indicates that floodwater has already been impounded by the dam. Small and large debris are beginning to accumulate in the reservoir area near the embankment.

DEBRIS ACCUMULATING IN  
TRASH RACK.
